Project: EXTERIOR FACADE RESTORATION  
**Milwaukee Public Museum**  
800 West Wells Street  
Milwaukee, WI 53233-1478

Subject: **Milwaukee Public Museum Marble Façade**  
**By**  
**GRAEF, Inc.**  
December, 2010

# **MILWAUKEE PUBLIC MUSEUM MARBLE FAÇADE**

**Project No. 2010-0161**

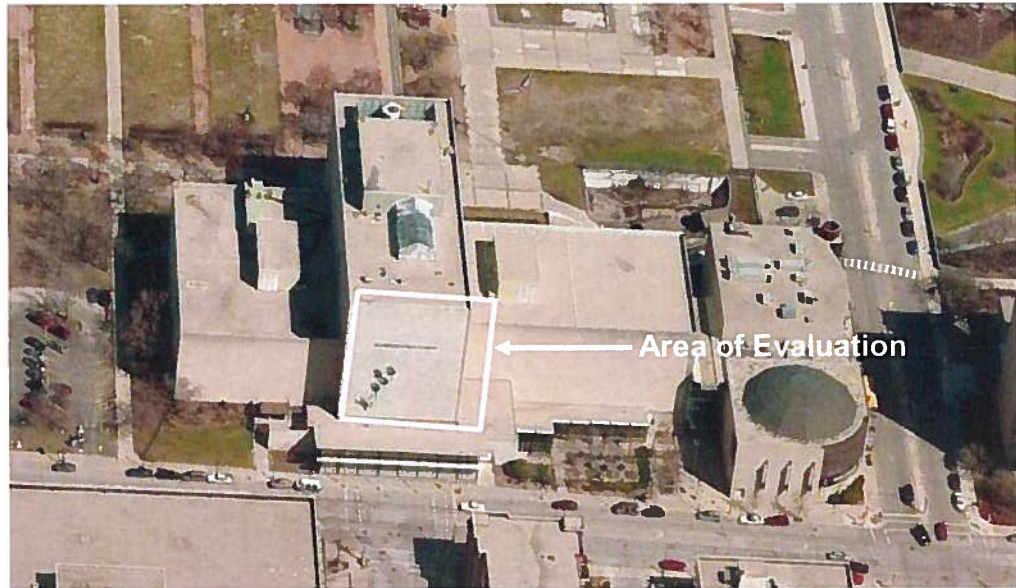
View from the south

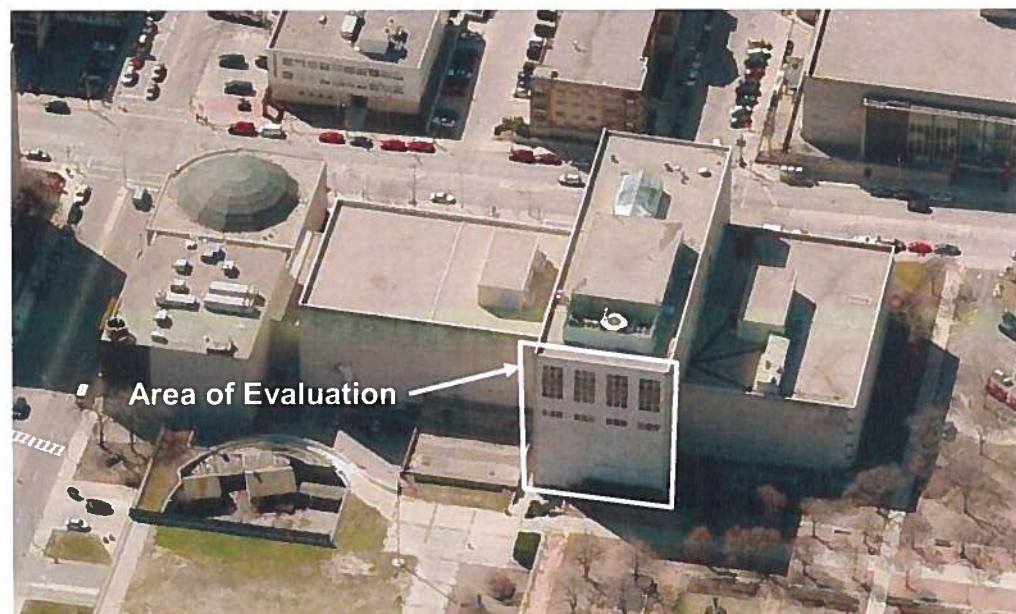
View from the north

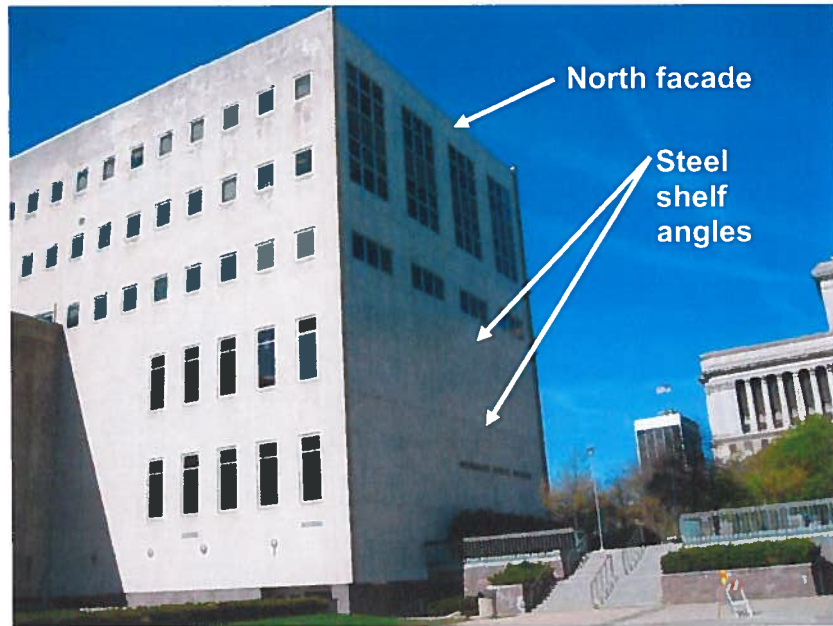
The north façade faces MacArthur Square Park, which is also bounded by the police headquarters, the county courthouse and the county jail. The north façade shows evidence of prior repair and replacement of some marble panels as well as continued cracking of the marble. The replaced panels were not an exact match and the color difference can easily be seen. These replaced panels have also cracked, emphasizing that the underlying problem of directing the moisture has not been resolved. Additionally, joints around the window system are deteriorating as well.

North facade facing MacArthur Square

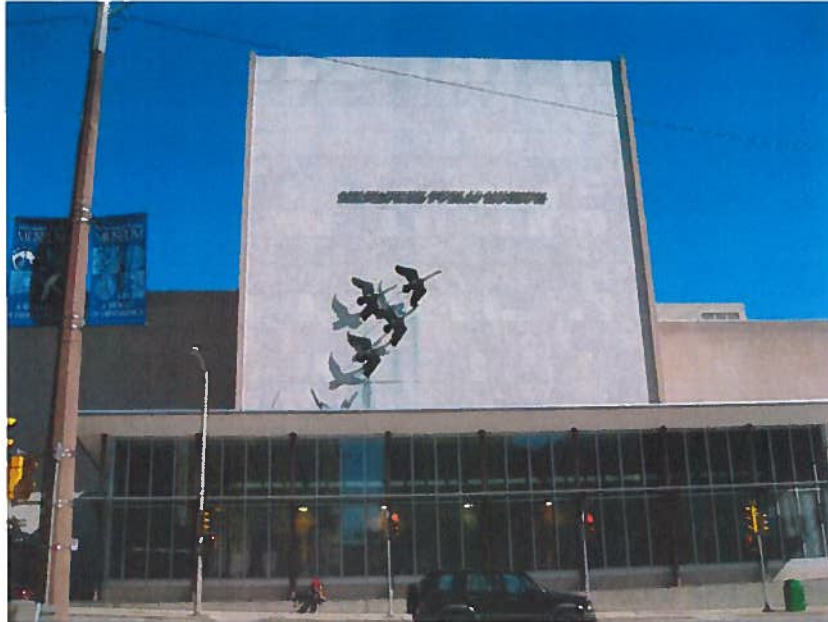
The south façade of the center portion of the building faces West Wells Street and also shows evidence of joint failure and cracking marble.

South Façade
